Upstream American Eel Passage Assessment

Lawrence Project (FERC No. 2800)

Essex Company, LLC A subsidiary of Patriot Hydro, LLC

April 2025

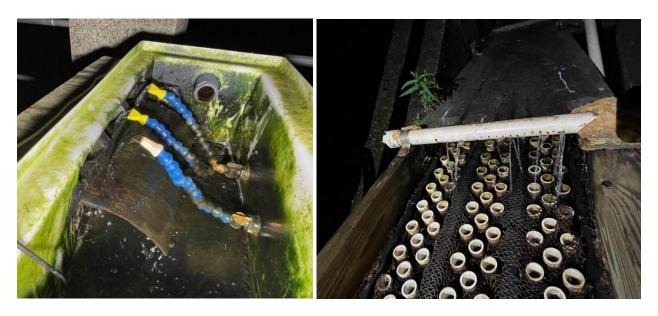
The second south side juvenile eel survey was conducted from 22:15 to 23:45 on July 25, 2024. The collection tank supply water was noted to be significantly reduced from the flow observed during the June 27 survey. Two of the three spray nozzles were failing to adequately water the ramp and the PVC spray bar on Ramp 4 appeared to be plugged with debris (Figure 5-2). It was noted that a blockage to the tank water supply resulted in the majority of water from the impoundment pump being fully diverted to the attraction flow provided at the entrance of the south side eel trap.

Figure 5-2. View of the south side eel trap collection tank (left photo) and ramp (right photo) water supply during the July 25, 2024 survey.

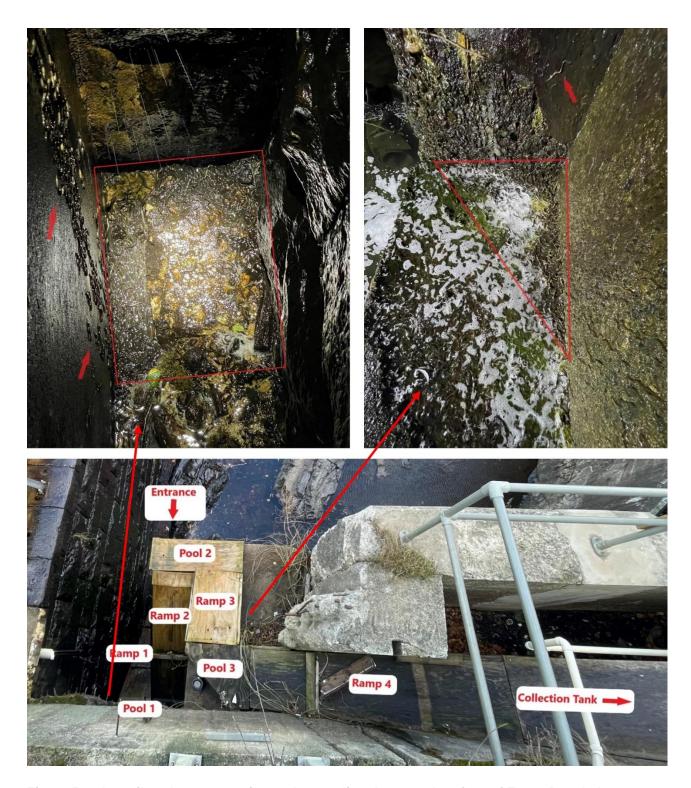
Figure 5-4. Juvenile eels congregating and ascending the wetted surface of Essex Dam below Pool 2 (left photo) and in the corner behind the south side eel trap entrance (right photo).

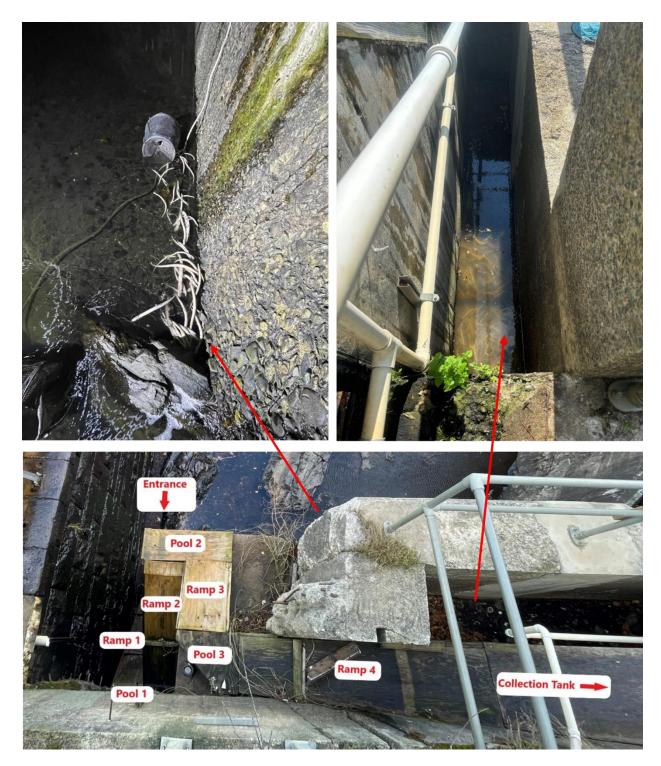
A high number of eel mortalities were observed from two primary areas during the July 25 survey. Dead eels from all size classes were observed in a large leakage-filled concrete trough adjacent to the uppermost ramp section (Figure 5-5). Additional eel mortalities (all individuals greater than 6 inches) were observed in the nearfield area below the Ramp 4 section.

Figure 5-5. Juvenile eel mortality areas associated with the south side eel ramp observed during July at the base of trough leakage (left photo) and inside the trough adjacent ramp section 4 (right photo).

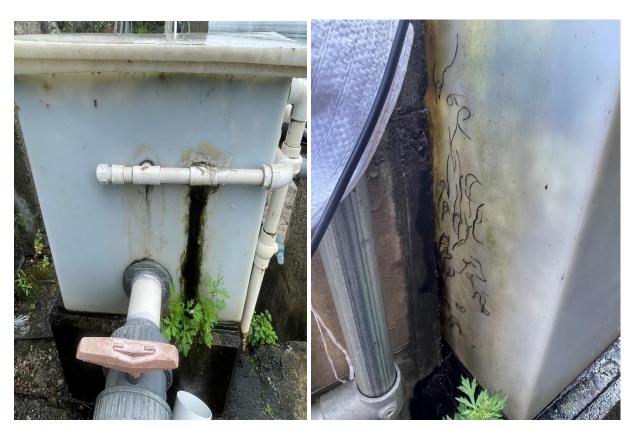
There was minimal leakage from the collection tank during the August survey but evidence of the previously observed leakage conditions was apparent (Figure 5-6). No eels were counted inside the collection tank. The greatest number of eels counted in the south side facility were observed in Pool 3 where around 100 juvenile eels were observed.

Figure 5-6. Dried algal growth (left photo) and desiccated juvenile eels (right photo) left in areas of previously observed leakage flows associated with the south side eel trap collection tank.

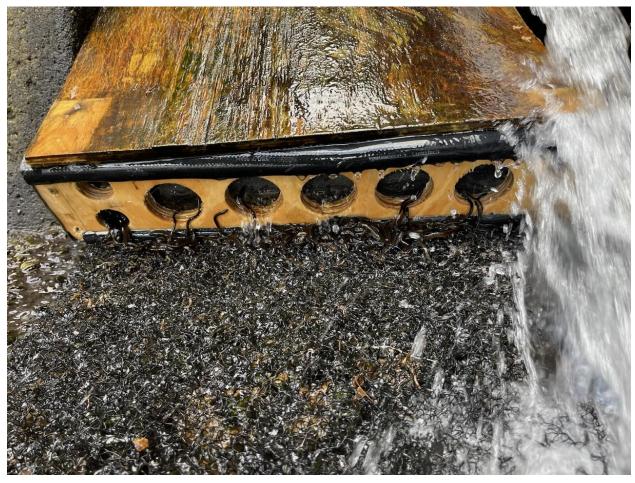
To evaluate the internal passage efficiency of the south side eel trap, the cover of the lowest ramp section was removed and a plywood panel fitted with mesh covered drain holes was installed at the ramp entrance (Figure 5-9). Once the lowermost ramp plywood panel was reinstalled, the end cap prevented test eels from exiting the ladder entrance during the test period¹.

Figure 5-9. Cover used to seal the south side eel ramp during internal efficiency testing.
