Upstream American Eel Passage Assessment

Lawrence Project (FERC No. 2800)

Essex Company, LLC A subsidiary of Patriot Hydro, LLC

April 2025

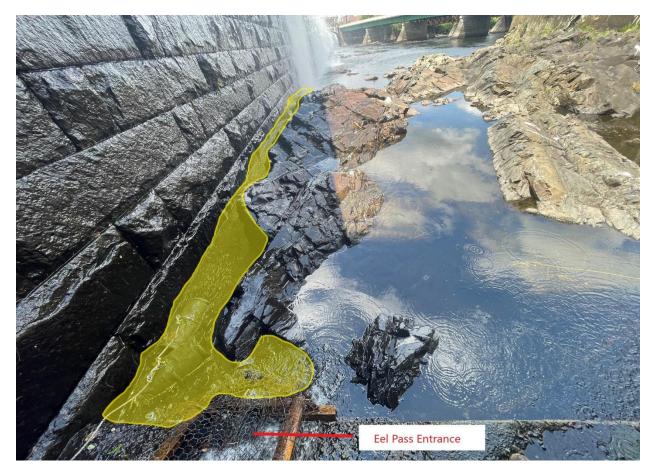
ascending the approach channel and in the water surrounding the eel pass entrance (Figure 5-1). Approximately 475 eels, all <6 inches, were observed climbing the rock wall face of the dam. Leakage from Pools and Ramps 1 through 3 created a wet surface on the surrounding concrete and contributed to attracting eels away from the eel pass entrance. An estimated 8,000 <6 inch and 4,000 6–12-inch eels were observed in the corner area below Pool 1. No eels in the 12+ size class were observed within the south side eel trap or the surrounding nearfield area during the June 27 survey.

Figure 5-1. View of the south side eel trap entrance and the approach pools conveying attraction water to the Lawrence tailrace.

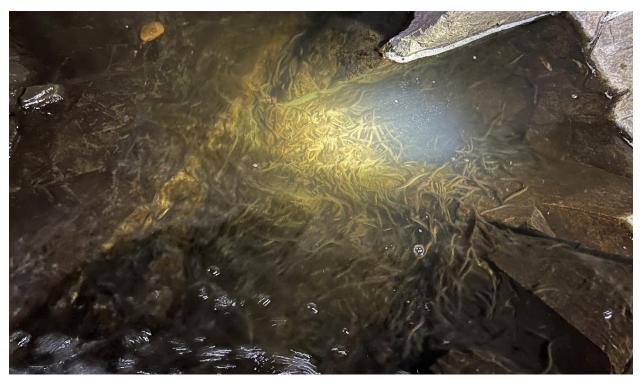
In the nearfield survey area, a total of 1,600 eels were observed ascending the approach channel to the concrete base of the north side eel lift (Figure 5-7). Approximately 70 eels were observed climbing on the poured concrete base of the lift and another 150 were observed climbing the face of Essex Dam. At the time of the survey, no eels were observed using the climbing substrate located on the poured concrete pad outside the hopper. All eels observed in the vicinity of the north side eel lift during the June 27 survey were in the smallest size class (i.e., less than 6 inches).

Figure 5-7. Juvenile American eels observed in the nearfield approach channel habitat associated with the north side eel lift during the June 27 survey.

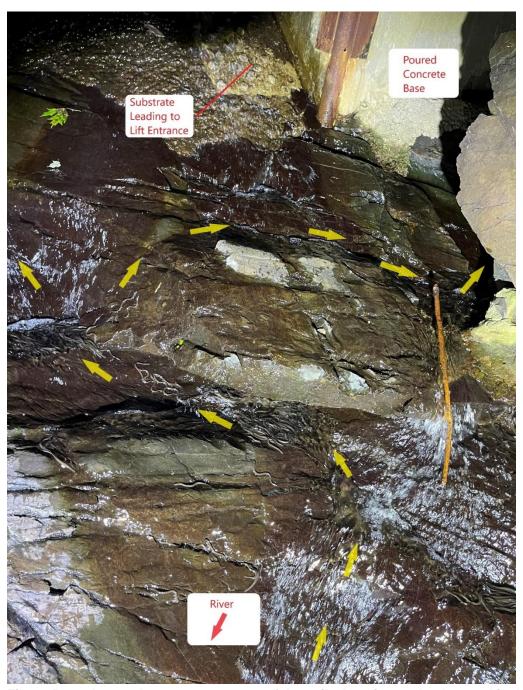
Within the nearfield survey area, approximately 1,250 juvenile eels were observed ascending the approach channel to the lift entrance. Eels were observed ascending a natural bedrock channel from the river to the concrete base of the north lift. The eels then split into two primary travel routes, directed by the attraction flow hoses located behind the lift, around the lift base and towards the top of the concrete base and dam face (Figure 5-8). A total of 52 juvenile eels were observed climbing the poured concrete base to the lift and another 450 were observed climbing the face of Essex Dam. As with previous surveys, no eels were observed using the climbing substrate located on the poured concrete pad outside the hopper. Surveyors approximated 500 juvenile eels in main river habitat just downstream of the entrance to the attraction flow channel leading up to the north side eel lift. Juvenile eels representing all three size classes were present during the August 22 north side eel lift survey.

Figure 5-8. Observed movement pattern of Juvenile American eels observed in the nearfield approach channel habitat associated with the north side eel lift during the August 22 survey.
